29th May 2023
Ref: 2123-LTR-02-290523.v1f

RE: Vibration Monitoring – Portion of Waratah Avenue (Between Arthur Lane and Belmore Road), Randwick NSW

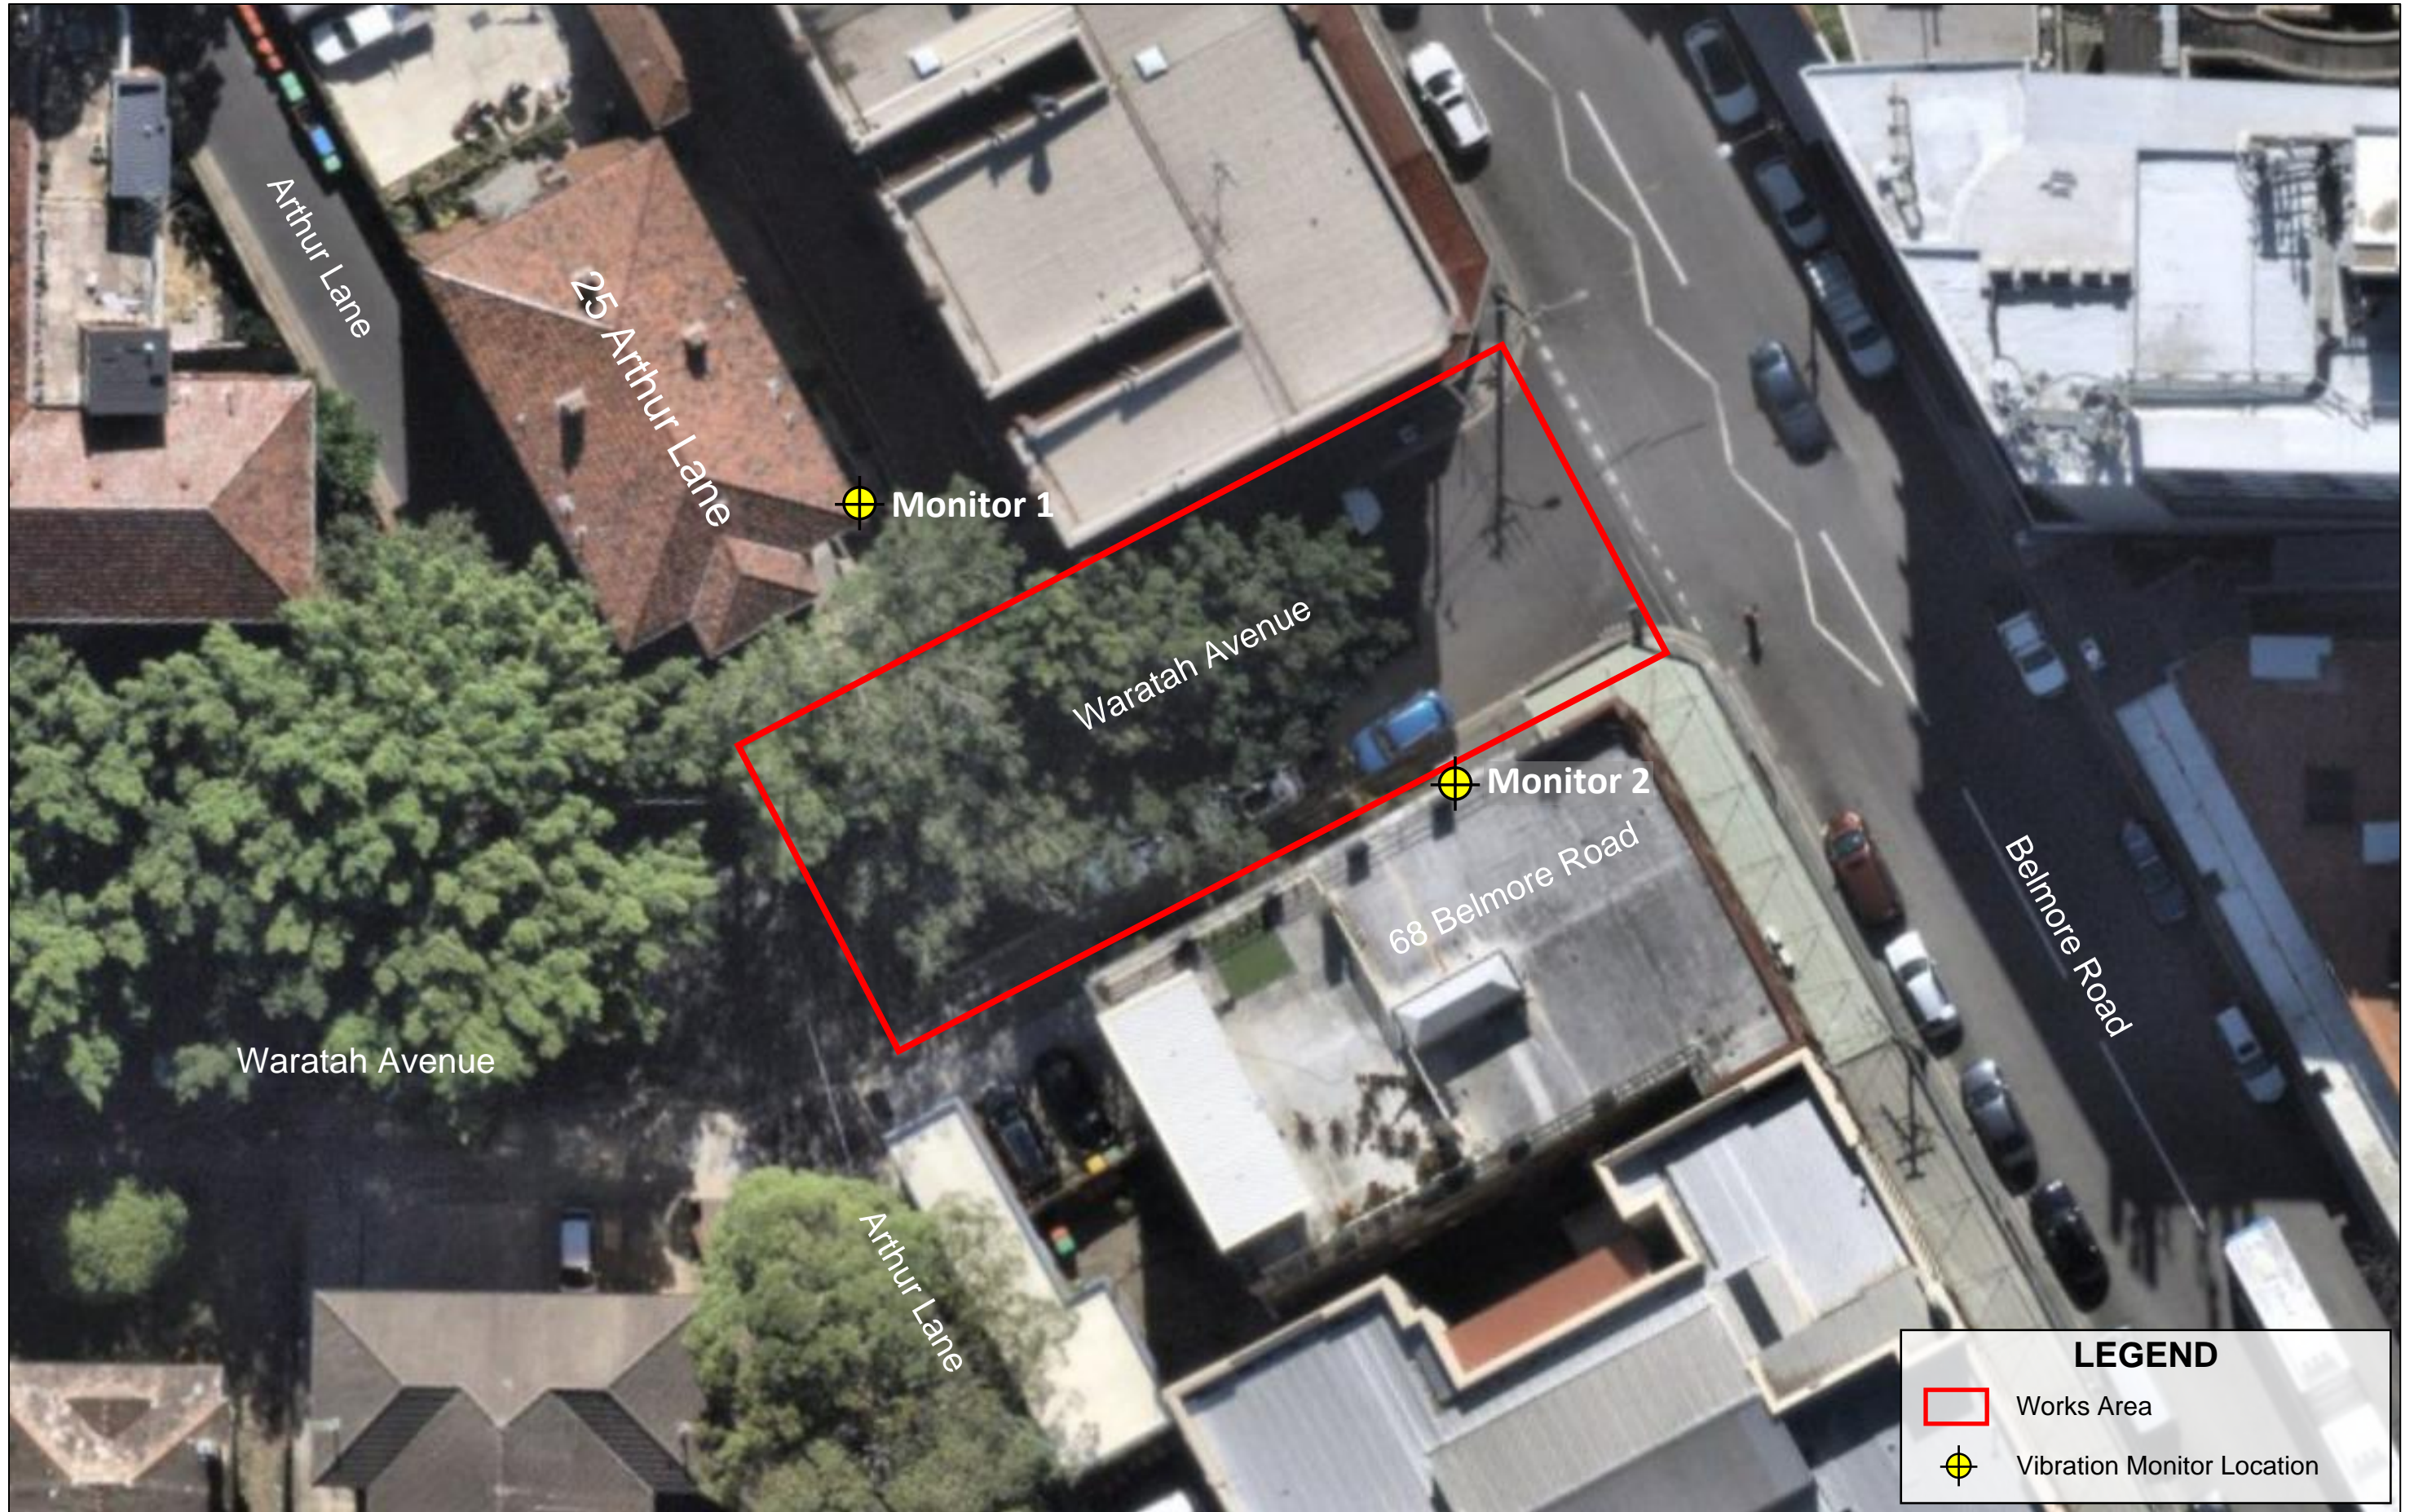
Figure Number:	1
Figure Date:	19 May 2023
Report Number:	2123-LTR-02-290523.v1f

SEG installed two (2) 'Profound Vibra' vibration monitors fitted with tri-axis geophones on the 18th of May 2023 to the external walls of properties adjacent the site (25 Waratah Avenue and 68 Belmore Road, Randwick NSW). The siting of monitors was selected to address particular resident concerns. Monitors were mounted to the walls of each structure using a concrete screw and the supplied mounting bracket for the vibration monitor. Refer to **Figure 1** for monitor locations.

Mounting of the monitors was undertaken in accordance with DIN 45669-2 Measurement of vibration emission – Part 2: Measuring method June 2005. Geophones were affixed using the supplied mounting bracket and screws to solid brick (25 Arthur Lane) and Sandstone wall materials (68 Belmore Road). The location of monitors is provided in **Figure 1**.

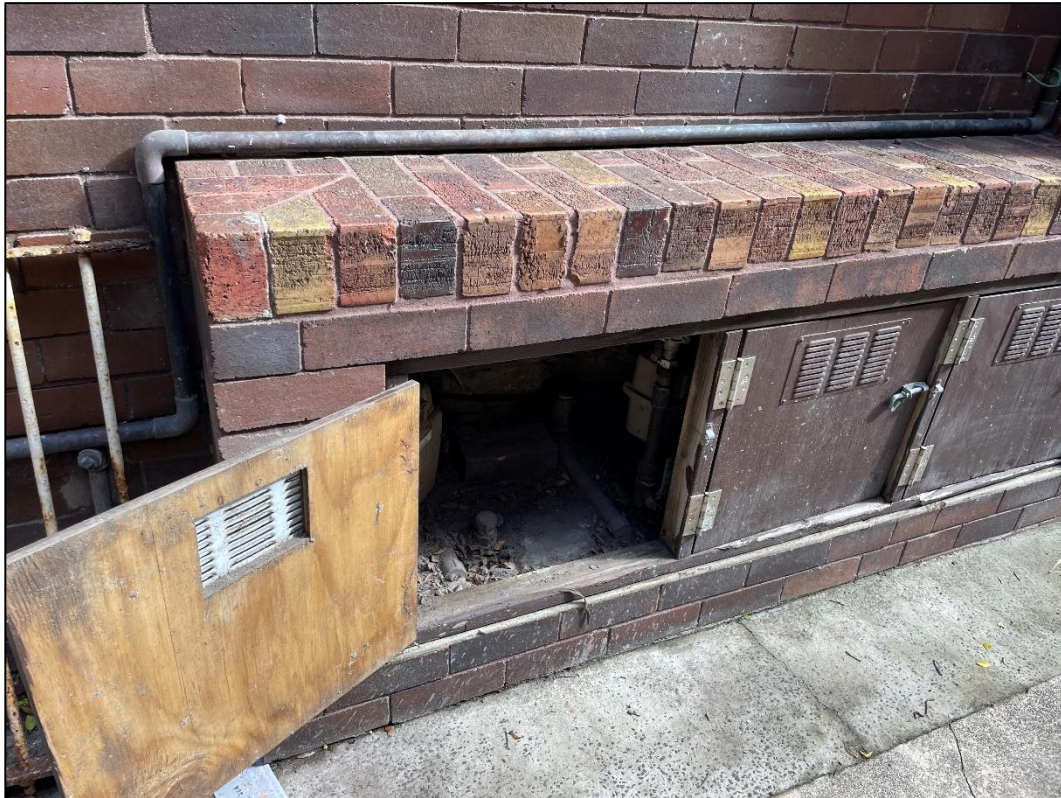
Photograph 1 Location of 'Monitor 1', affixed to the brick façade (within the gas meter enclosure) on the northern side of the building, approximately 15 m from the closest edge of works.

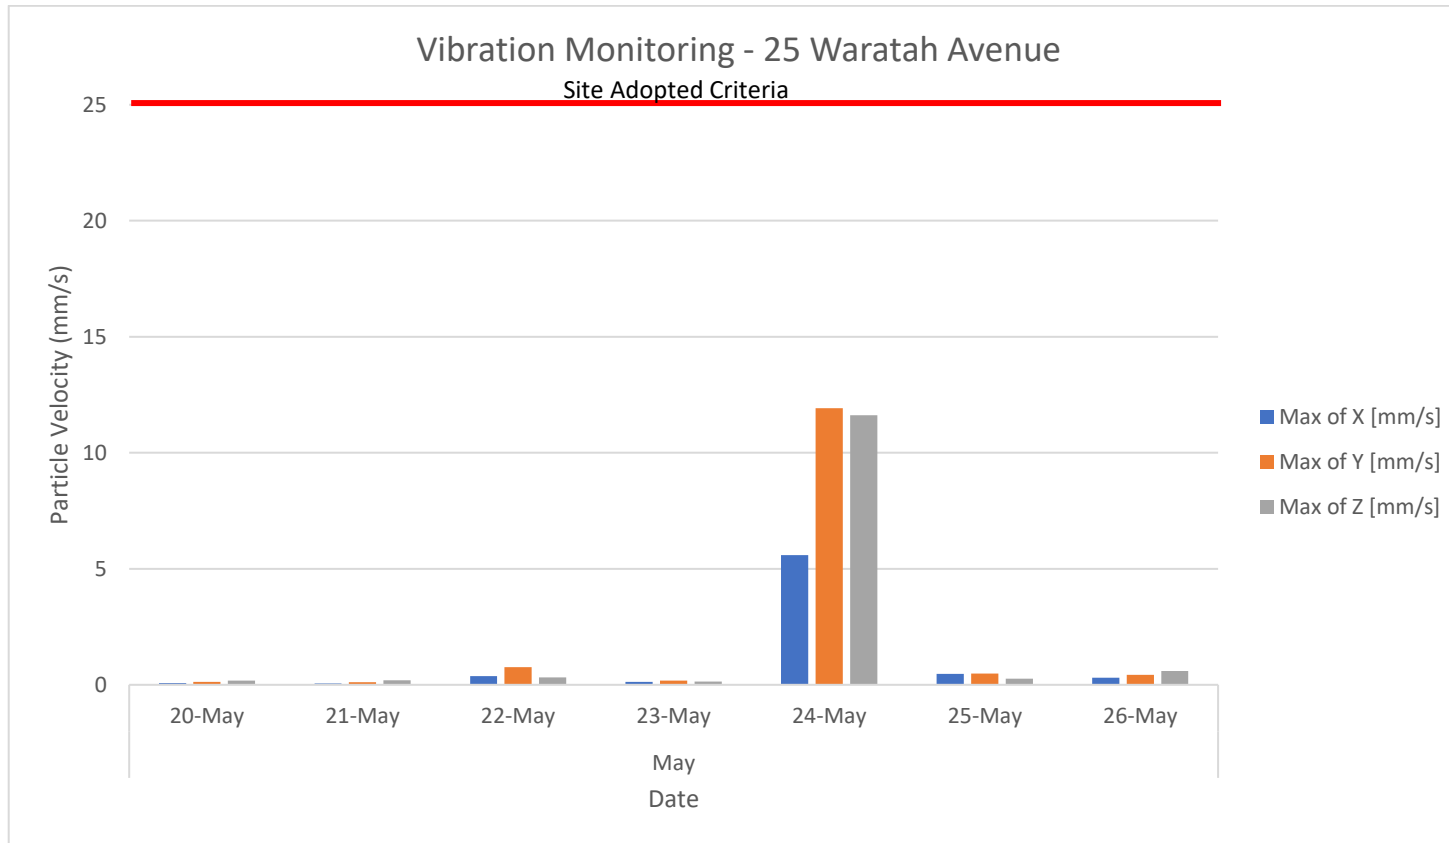
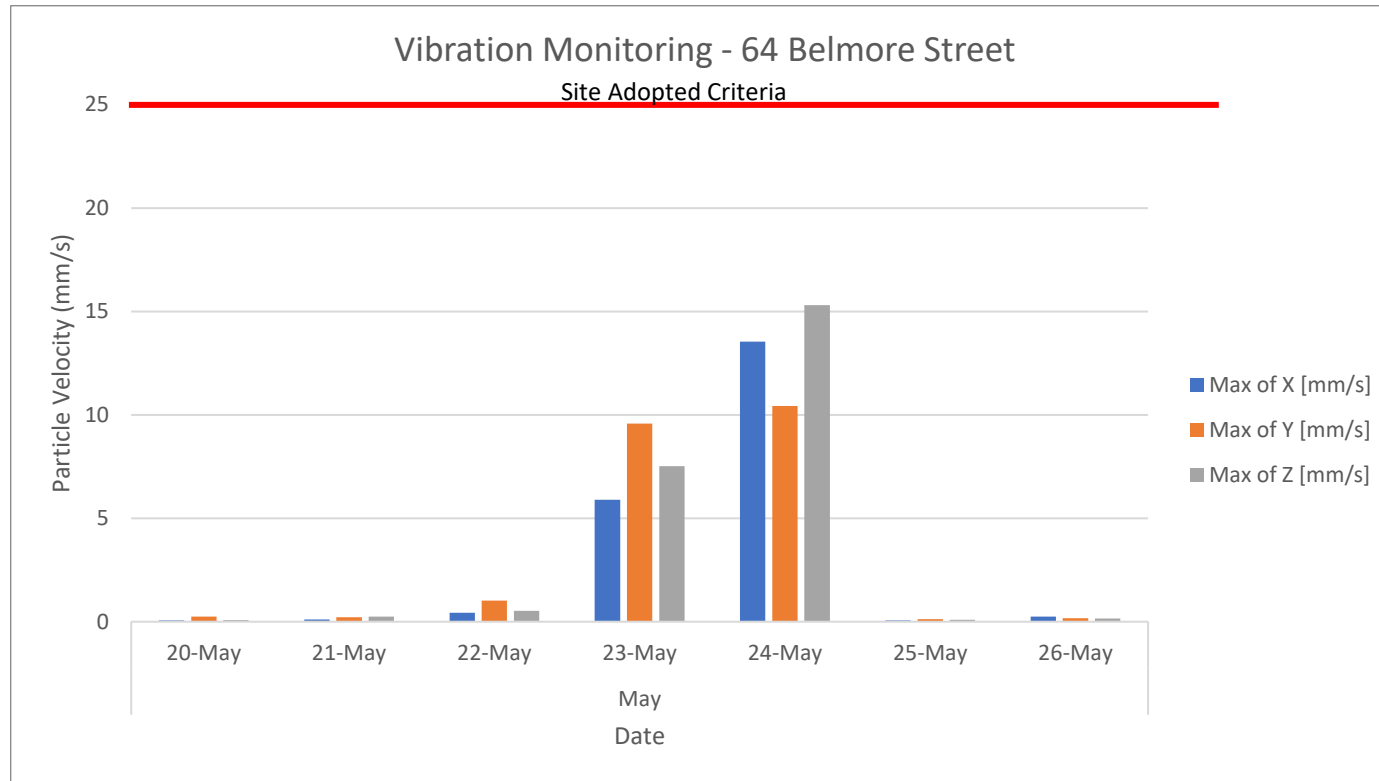
VIBRATION RESULTS SUMMARY TABLES

A summary of maximum vibration values recorded across the day are presented in **Appendix A**. Vibrations measured and correlated to the expected frequency of vibration inducing equipment.

- Vibration levels measured at residences adjacent to the site between the 20th of May and the 26th of May 2023 were found to be well below relevant criteria; and
- Vibration reduction methodologies implemented on-site are considered adequate and above industry best practice, and as such, no further controls are recommended.
