6<sup>th</sup> June 2023  
Ref: 2123-LTR-03-060623.v1f

## **RE: Vibration Monitoring – Portion of Waratah Avenue (Between Arthur Lane and Belmore Road), Randwick NSW**

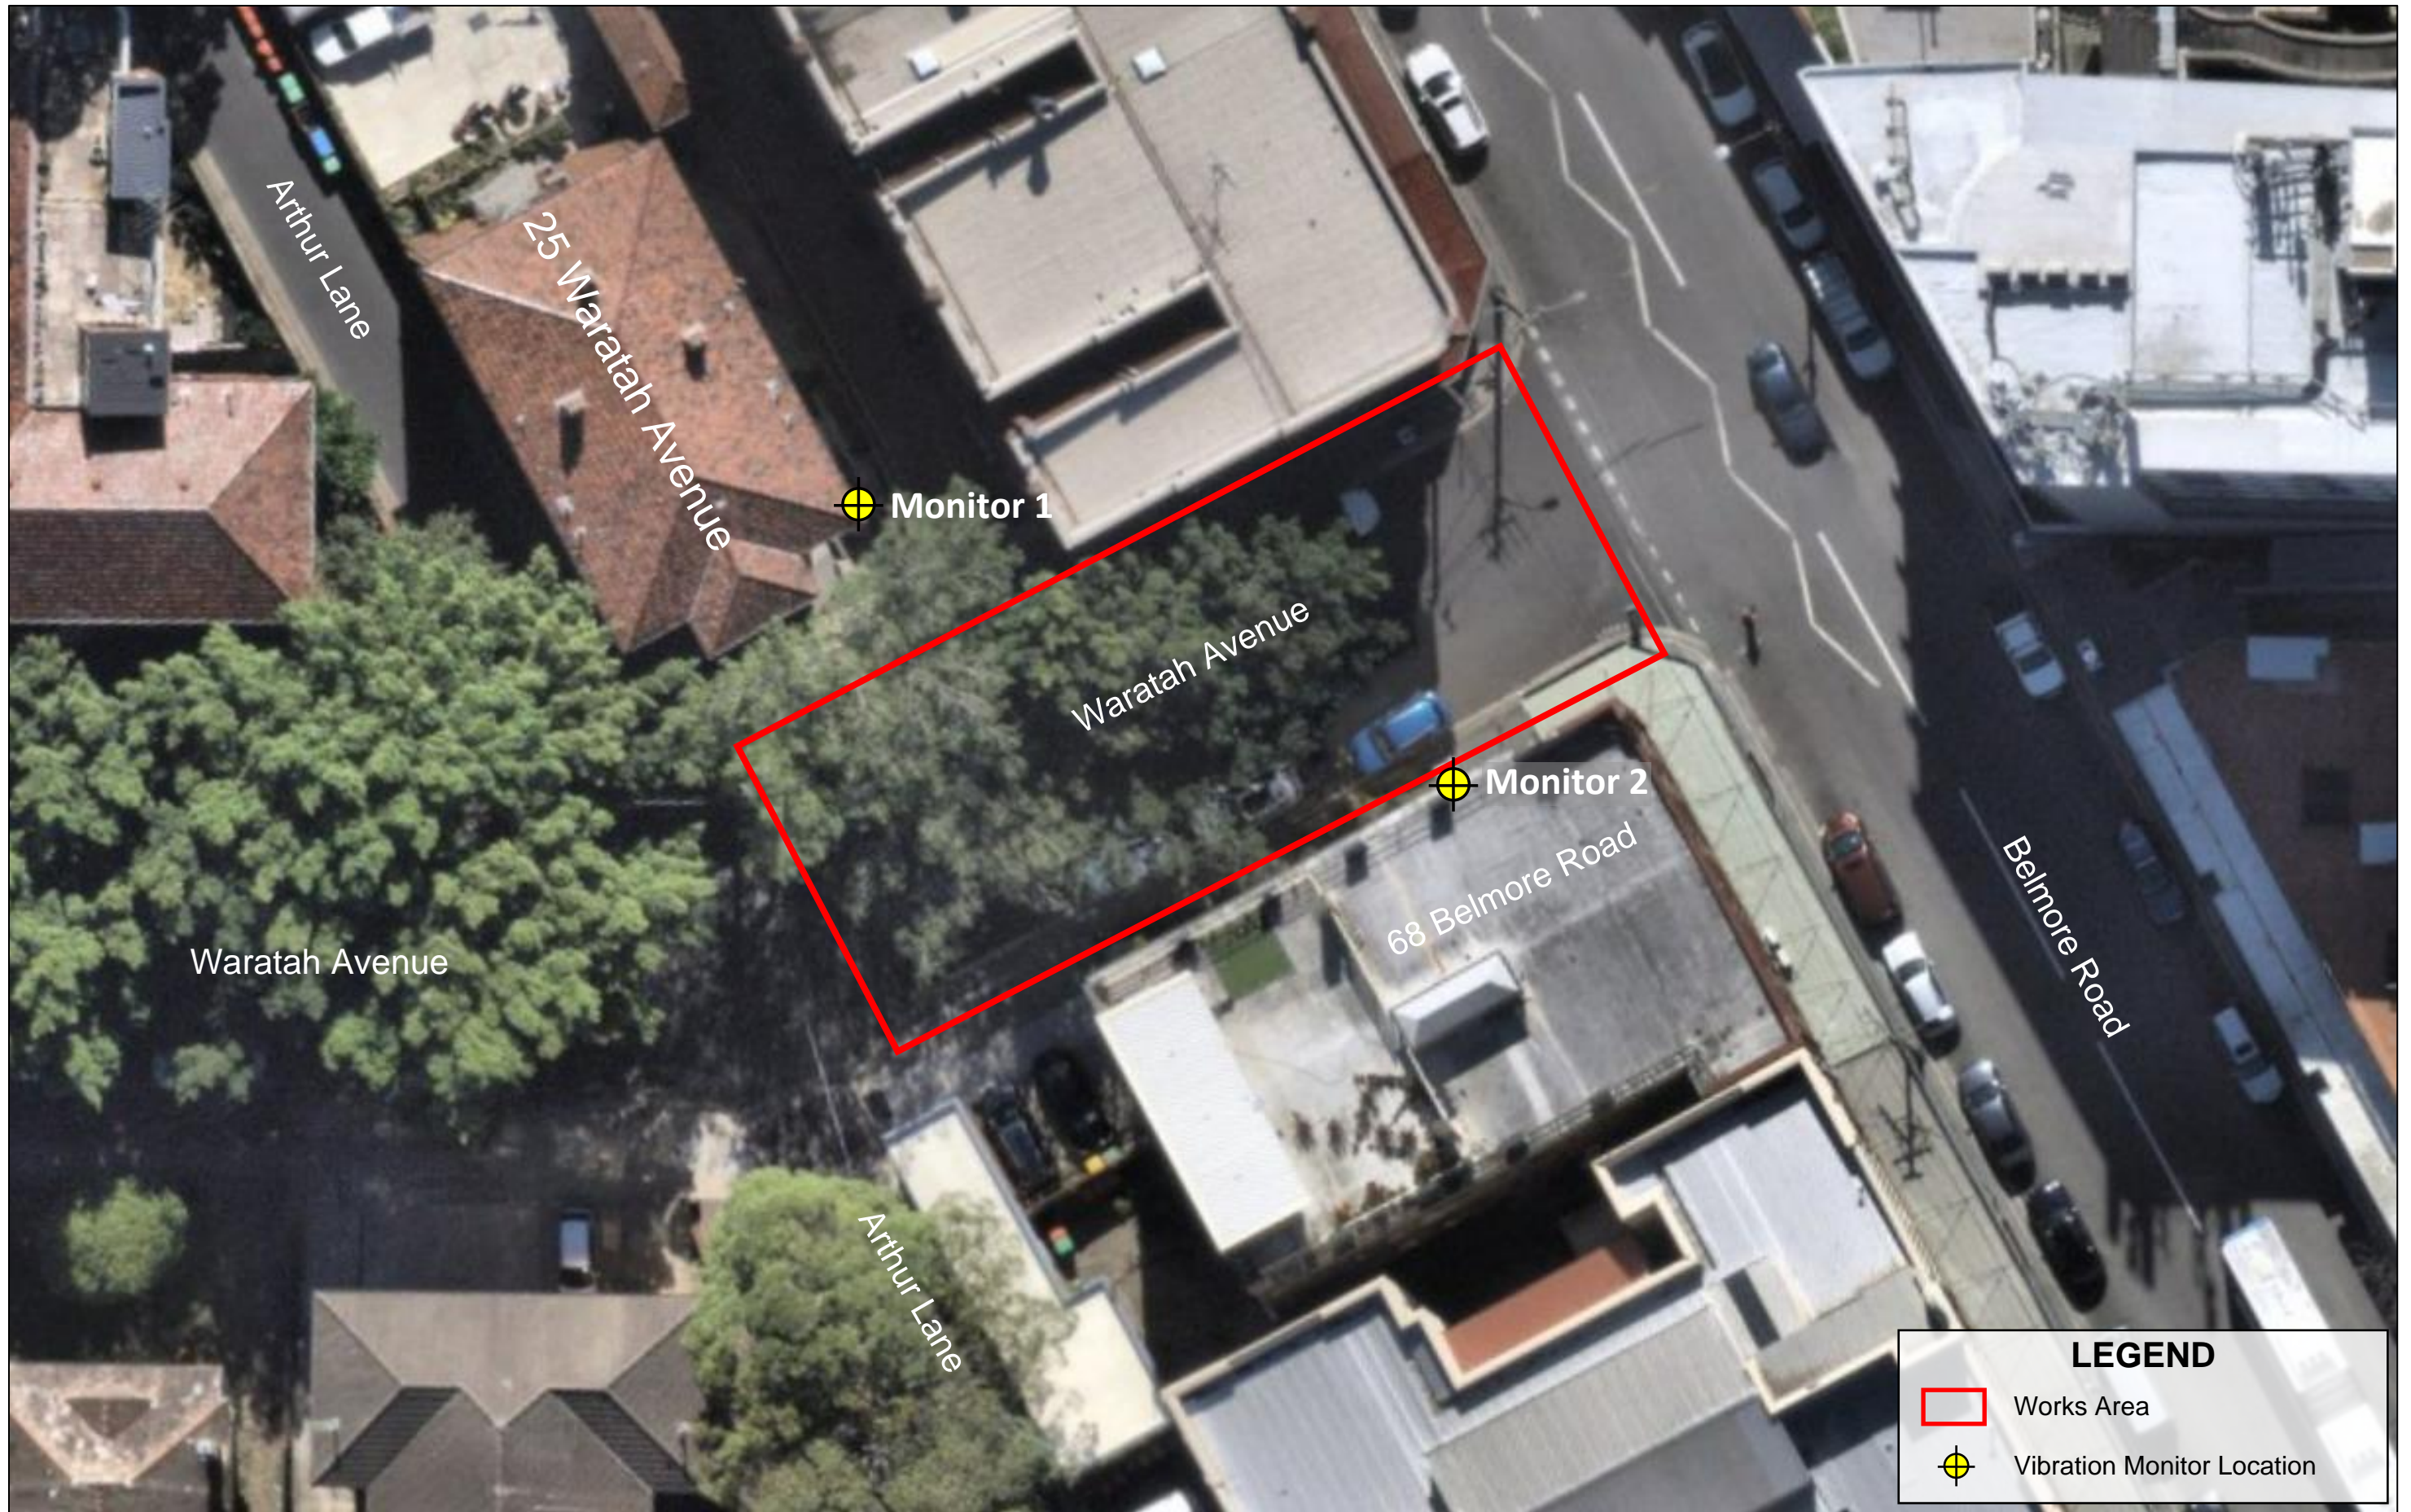
Figure Number:	1
Figure Date:	19 May 2023
Report Number:	2123-LTR-03-060623.v1f

SEG installed two (2) 'Profound Vibra' vibration monitors fitted with tri-axis geophones on the 18<sup>th</sup> of May 2023 to the external walls of properties adjacent the site (25 Waratah Avenue and 68 Belmore Road, Randwick NSW). The siting of monitors was selected to address particular resident concerns. Monitors were mounted to the walls of each structure using a concrete screw and the supplied mounting bracket for the vibration monitor. Refer to **Figure 1** for monitor locations.

Mounting of the monitors was undertaken in accordance with DIN 45669-2 Measurement of vibration emission – Part 2: Measuring method June 2005. Geophones were affixed using the supplied mounting bracket and screws to solid brick (25 Arthur Lane) and Sandstone wall materials (68 Belmore Road). The location of monitors is provided in **Figure 1**.

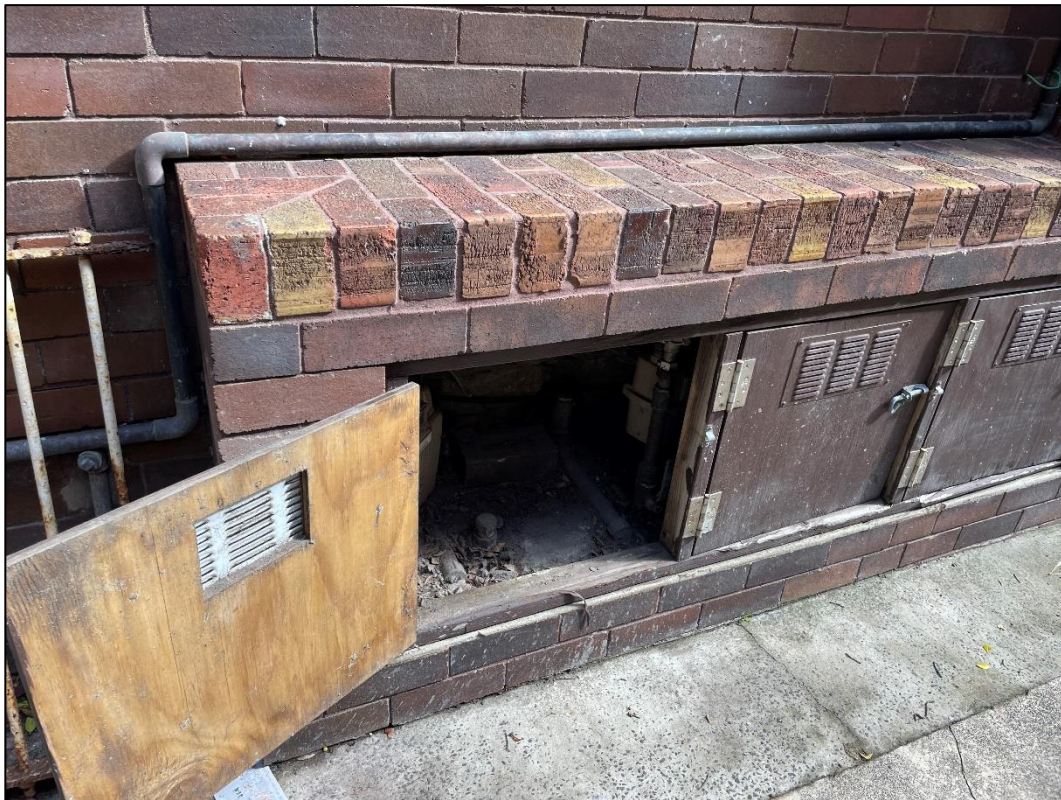
**Photograph 1** Location of 'Monitor 1', affixed to the brick façade (within the gas meter enclosure) on the northern side of the building, approximately 15 m from the closest edge of works.

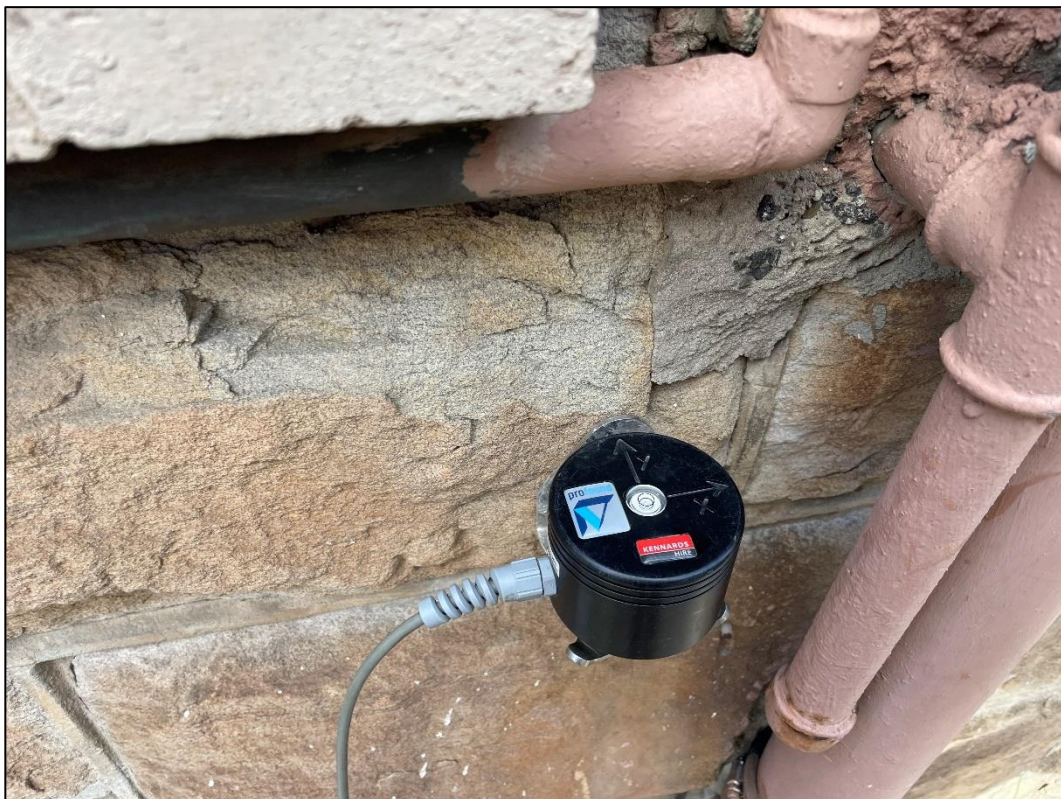
**Photograph 2** Location of 'Monitor 2', affixed to the sandstone façade on the western side of the building, approximately 5 m from the closest edge of works. Note that the monitor has been affixed through an existing drilled hole in the sandstone which will be re-affixed at the completion of monitoring.

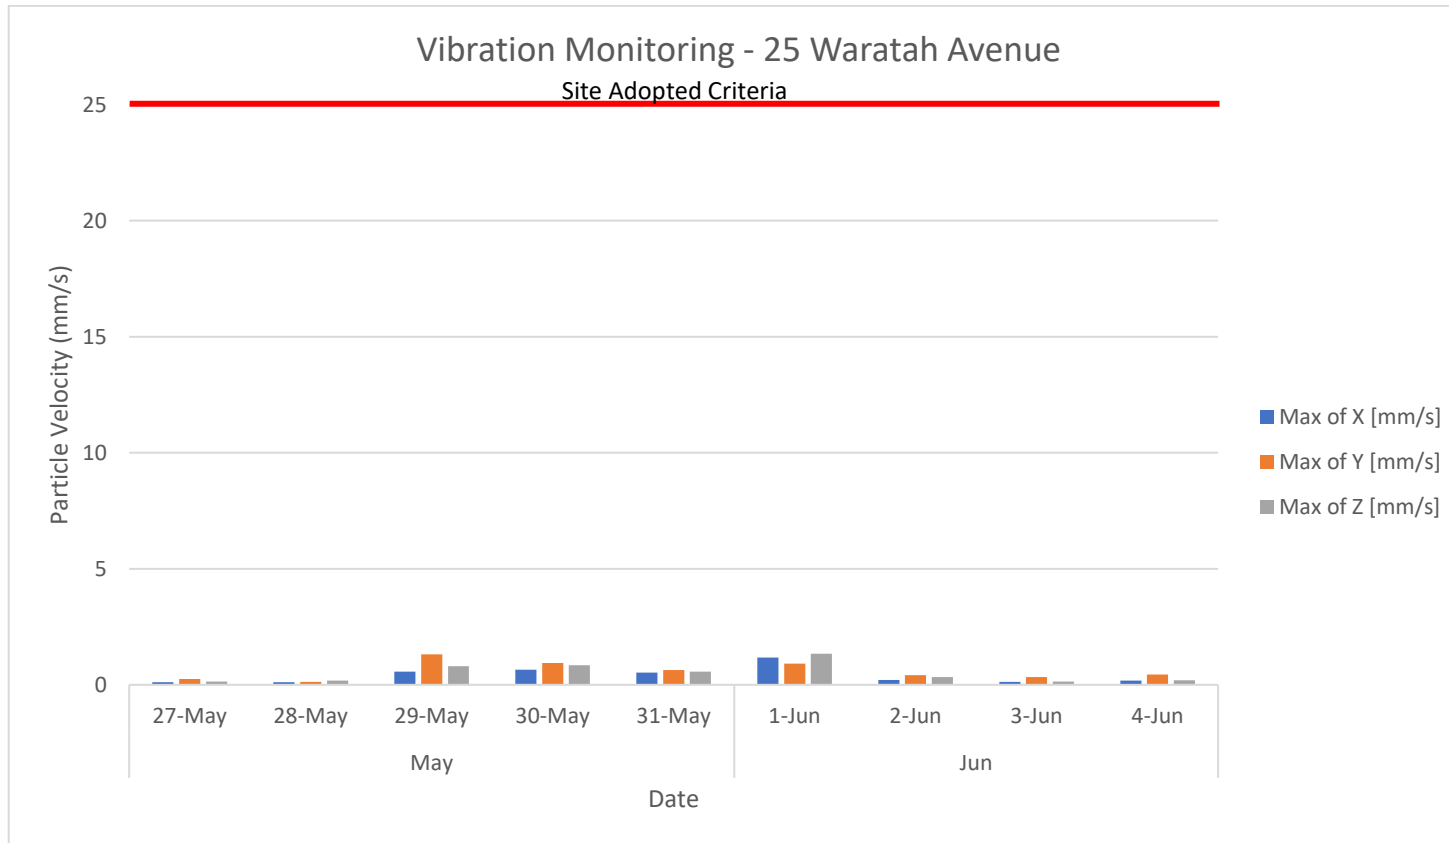
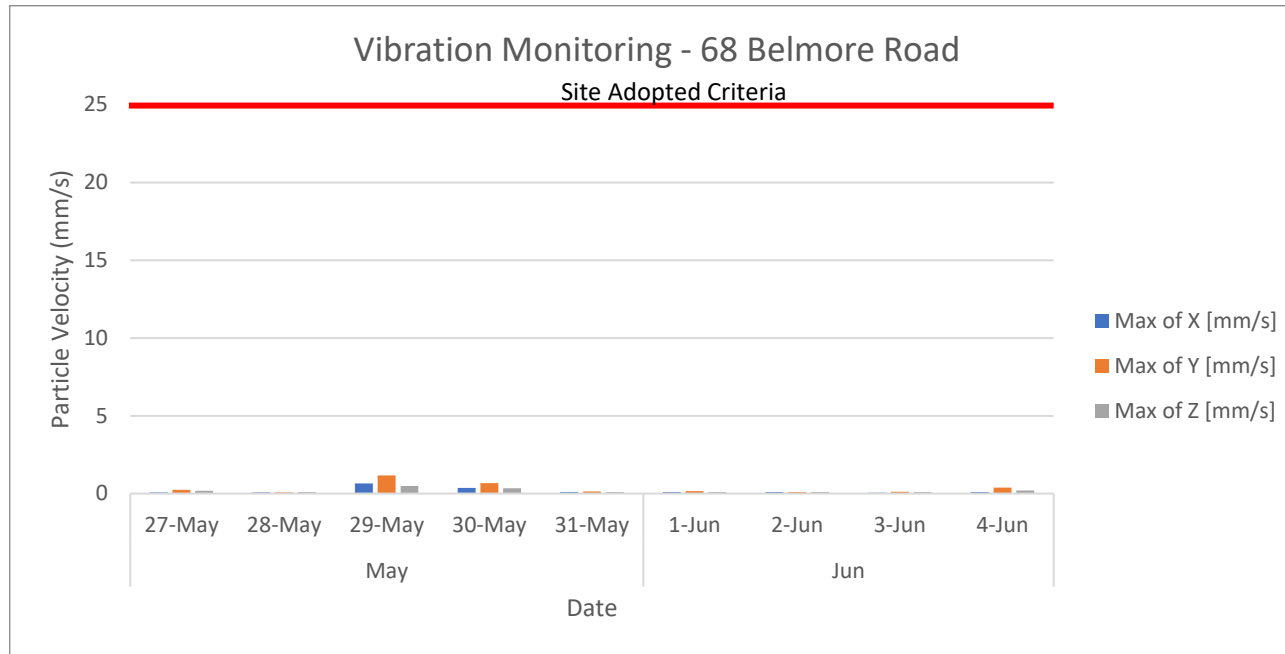
**VIBRATION RESULTS SUMMARY TABLES**

A summary of maximum vibration values recorded across the day are presented in **Appendix A**. Vibrations measured and correlated to the expected frequency of vibration inducing equipment.

- Vibration levels measured at residences adjacent to the site between the 27<sup>th</sup> of May and the 4<sup>th</sup> of June 2023 were found to be well below relevant criteria; and
- Vibration reduction methodologies implemented on-site are considered adequate and above industry best practice, and as such, no further controls are recommended.
