Evan Buntoro
Project Manager
Randwick City Council

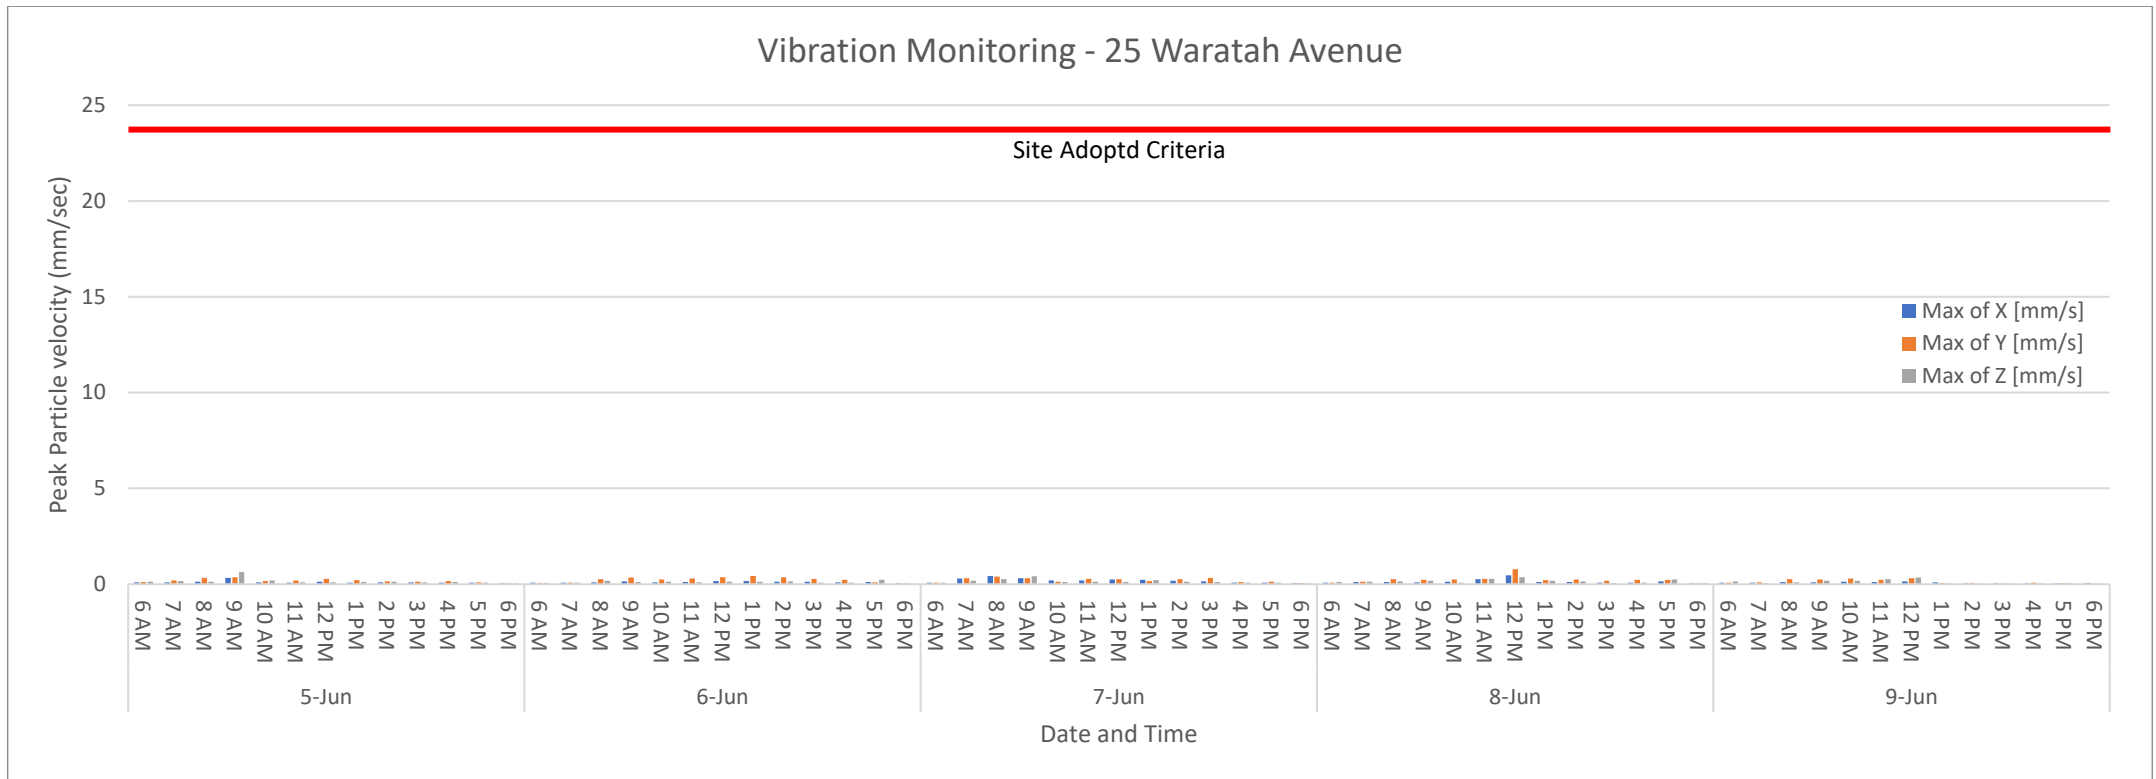
VIBRATION RESULTS SUMMARY TABLES

A summary of maximum vibration values recorded across the day are presented in **Appendix A**. Vibrations measured and correlated to the expected frequency of vibration inducing equipment. General frequency ranges recorded for vibrations induced by site equipment have been observed to range from $\approx 20 - 40$ Hz. Using an approximate polynomial, SE have chosen a limit of 24 mm/s based on a conservative assumption of vibrations occurring at 20 Hz and extrapolating an approximate polynomial curve from information provided in **Table 1**. $(0.0207 \times \text{Hz}^2 + 0.0611 \times \text{Hz} + 14.424) \approx 24$ mm/sec at 20 Hz.

No exceedances of the adopted criteria were noted for the duration of the monitoring period.
